TB9AES018 Incident Report

11/24/2014

This report is an independent investigation performed by the project engineer of the detuning of TB9AES018 superconducting RF cavity on October 28, 2014. The niobium cavity was plastically deformed during a pressure test. It was later discovered that the cavity was insufficiently restrained to counteract the forces experienced during the pressure test.

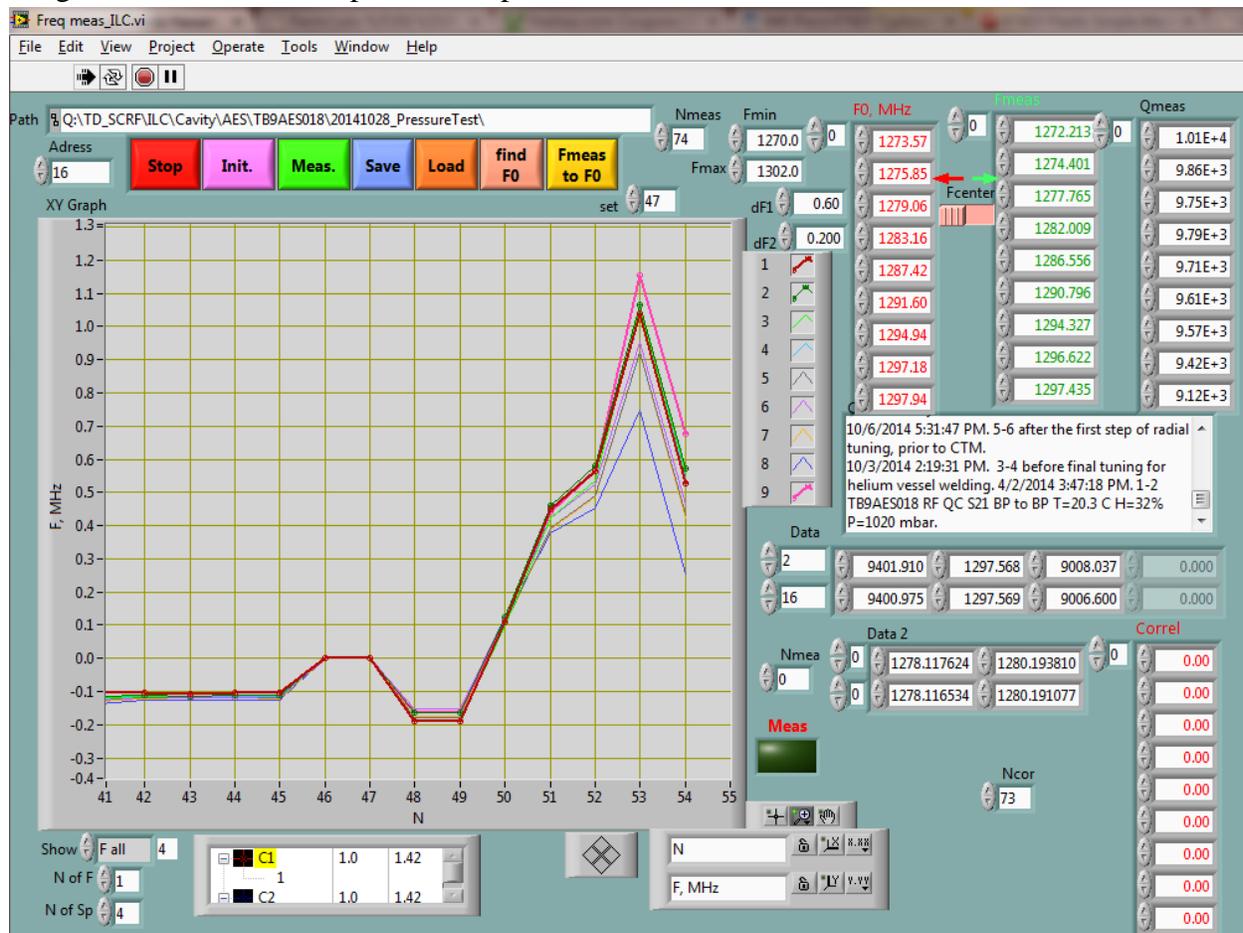
Figure 1 RF Frequency Shift on TB9AES018

Figure 1 displays the TB9AES018 cavity frequency shift under the different conditions which are given in Table 1 for important test points.

Test Point	Cavity Pressure	Helium Pressure	π mode shift	Comment
45	1 atm	1 atm	-100 kHz	Helium vessel welding complete, still warm
46	1 atm	1 atm	0 kHz	Helium vessel welding complete, cooled to room

temperature
47	1 atm	1 atm	0 kHz	Helium vessel welding complete, cooled to room temperature
48	1 atm	1 atm	-160 kHz	Following helium vessel leak check and subsequent backfill
49	1 atm	1 atm	-160 kHz	Following helium vessel leak check and subsequent backfill
50	1 atm	9 psig	100 kHz	During pressure test
51	1 atm	17 psig	440 kHz	During pressure test
52	1 atm	20.5 psig	560 kHz	During pressure test
53	1 atm	27 psig	1,150 kHz	During pressure test
54	1 atm	1 atm	680 kHz	Following pressure test

The cavity had a 680 kHz frequency shift following the test with atmospheric pressure in the helium and beamline spaces. This is an 840 kHz shift relative to the start of the pressure test. The beam pipe flange at the bellows end of the cavity showed a 1° departure from vertical, with the lower side further out. This is presumably due to the bellows brace assembly adding more resistance on the top of the cavity system. The field flatness was determined to be ~34% at this point. The field flatness had been >95% following the welding of the helium vessel.

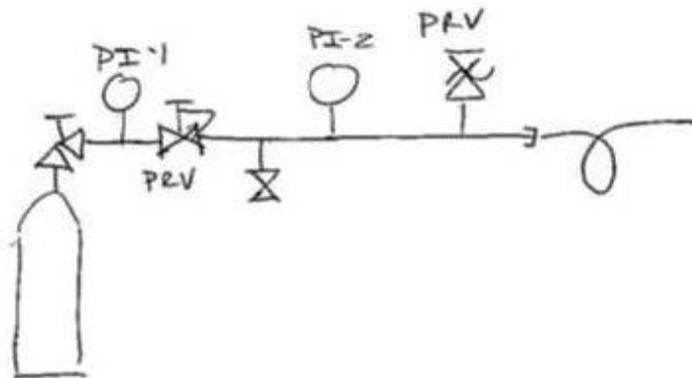
Test Setup

Test Pressure
34.5 psig

PI-2
0-100 psig

PRV
35.4 psig relief

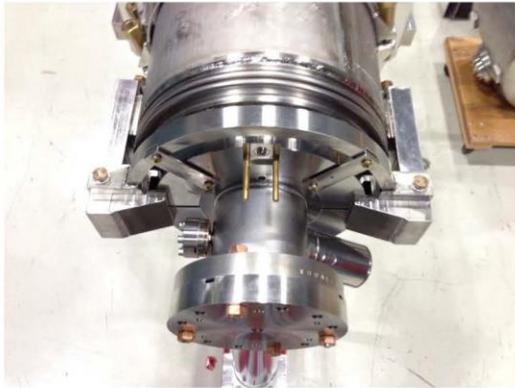
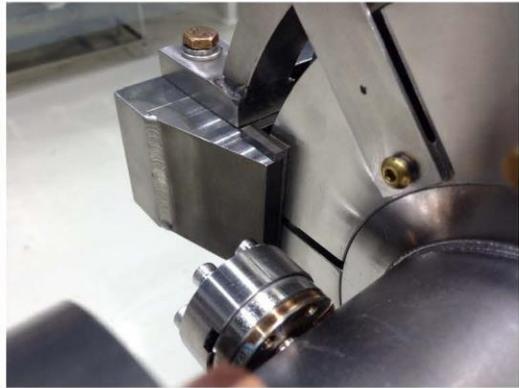
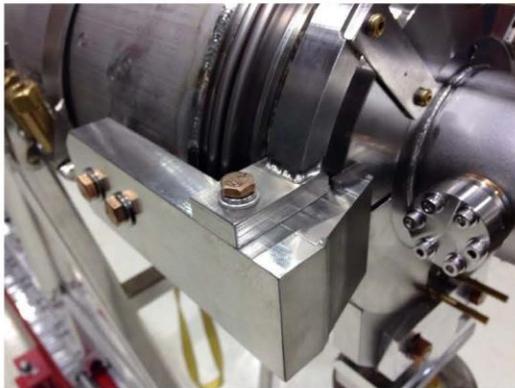
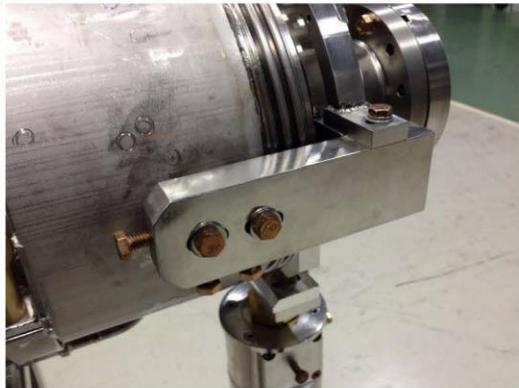
Note 3: The bellows brace arms (see attached images) are installed on the cavity and protect the cavity from excessive expansion. It is important to make sure that the titanium bellows at the end of the helium vessel is supported during the pressure test.

6. Ensure the bellows brace arms (see attached images) are installed on the cavity and protect the cavity from excessive expansion. It is important to make sure that the titanium bellows at the end of the helium vessel is supported during the pressure test.

7. Check to see all bolts are present and tight in the bellows brace arms (see attached images).
8. Take RF measurement. Record starting frequency. Make sure frequency is in the range of 1297.85 - 1298.05 MHz.
